**Flood Control Project Maintenance
Levee Inspections**

Fall 2013 Levee Maintenance Deficiency Summary Report

Reclamation District No. 0787 Fair

Waterway			Bank	Unit Miles
Unit No. 01 Colusa Basin Drain			Left	4.40
	Spring (March - May)	Summer (June - August)	(September - November) Fall	Winter (December - February)
Unit Maintenance Rating (Fall Only)			A	
Date of Inspection	-		10/04/2013 - 10/04/2013	
DWR Inspector	John Williamson		John Williamson	
Accompanied By	Marty Stripling River Gardens Farm		Marty Stripling River Gardens Farm	
	Roger Cornwell Rivergarden Farms RD 787		Roger Cornwell Rivergarden Farms RD 787

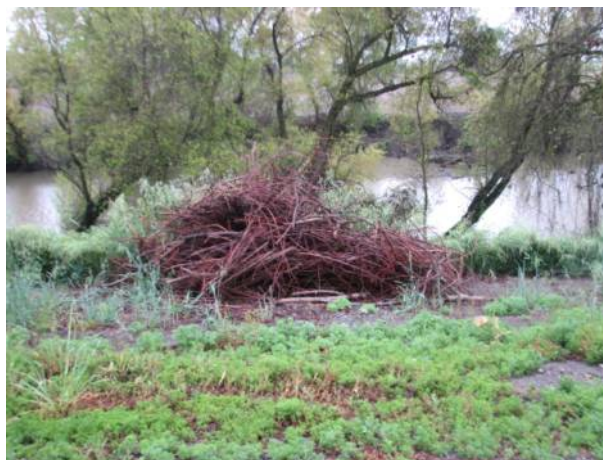
Levee Mile Report Line	7
Start Levee Mile	0.64
End Levee Mile	0.64
Location	Water Side
Category	Earthen Levee
Item	Encroachments

Prunings pile along the shoulder of the waterside levee. Spring 2013

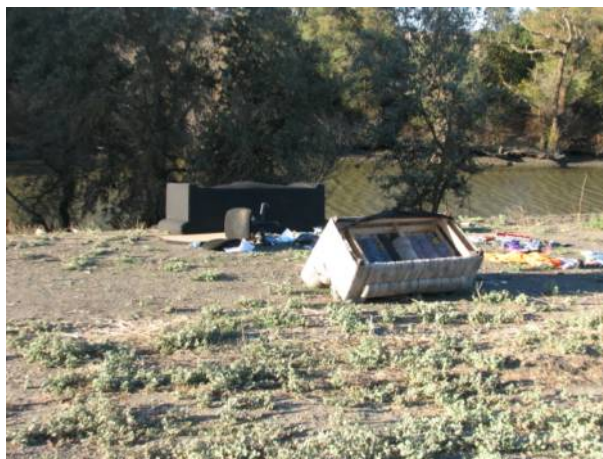
Levee Mile Report Line	10
Start Levee Mile	1.41
End Levee Mile	1.41
Location	Water Side
Category	Earthen Levee
Item	Encroachments

Household debris has been place on the berm area. Fall 2013

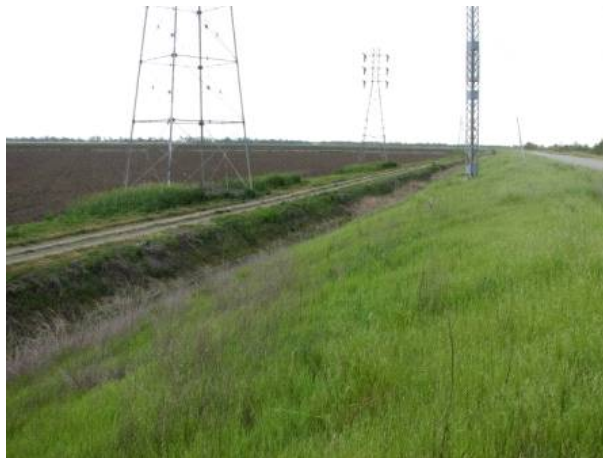
Levee Mile Report Line	11
Start Levee Mile	1.57
End Levee Mile	2.71
Location	Land Side
Category	Earthen Levee
Item	Encroachments

Agricultural ditch runs along landside the distance of the district.

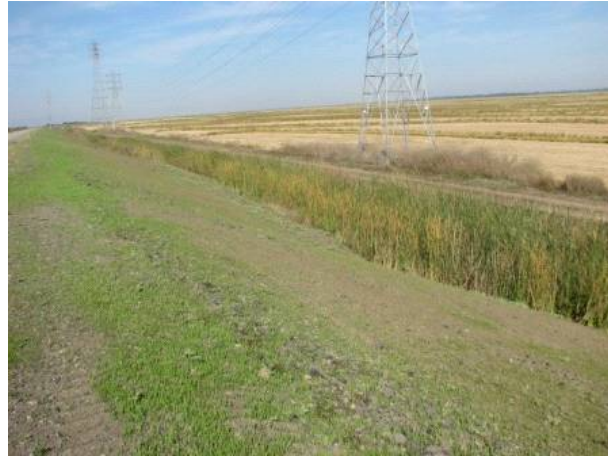
Levee Mile Report Line	11
Start Levee Mile	1.57
End Levee Mile	2.71
Location	Land Side
Category	Earthen Levee
Item	Encroachments

A view of the agricultural ditch in the fall of 2011.

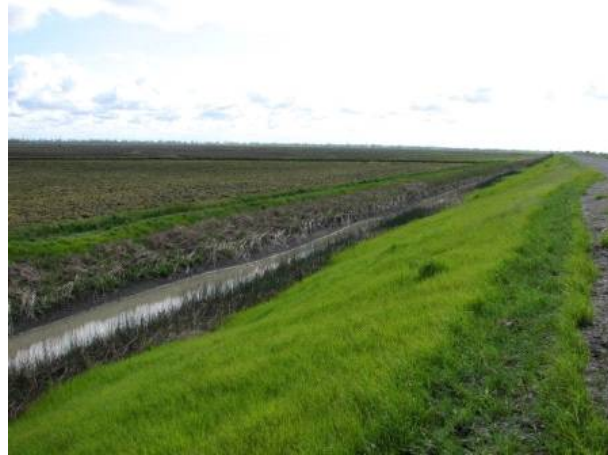
Levee Mile Report Line	13
Start Levee Mile	3.11
End Levee Mile	4.37
Location	Land Side
Category	Earthen Levee
Item	Encroachments

Ditch along landside toe.

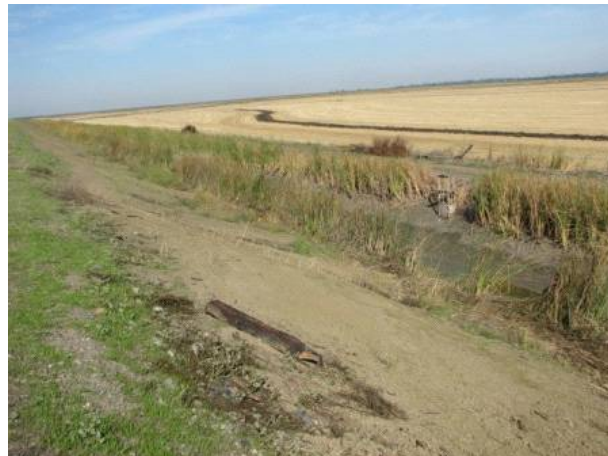
Levee Mile Report Line	13
Start Levee Mile	3.11
End Levee Mile	4.37
Location	Land Side
Category	Earthen Levee
Item	Encroachments

A current view of the agricultural ditch photo taken in fall of 2011.
